Limited Visual Dam Safety Inspections

OA00020

Opaepala 15 Reservoir

May 2006

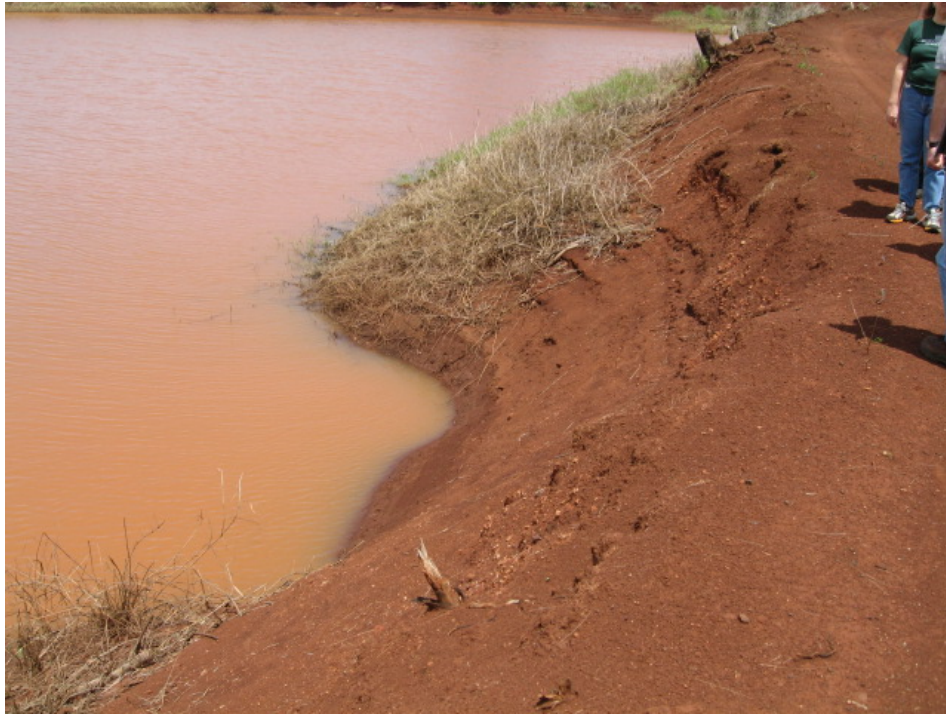
Photo 1 Steepened slope near intake entrance.

- d. Repair gully that extends from crest.
- e. Steepened slope at inlet will need to be monitored and repaired if it becomes unstable.

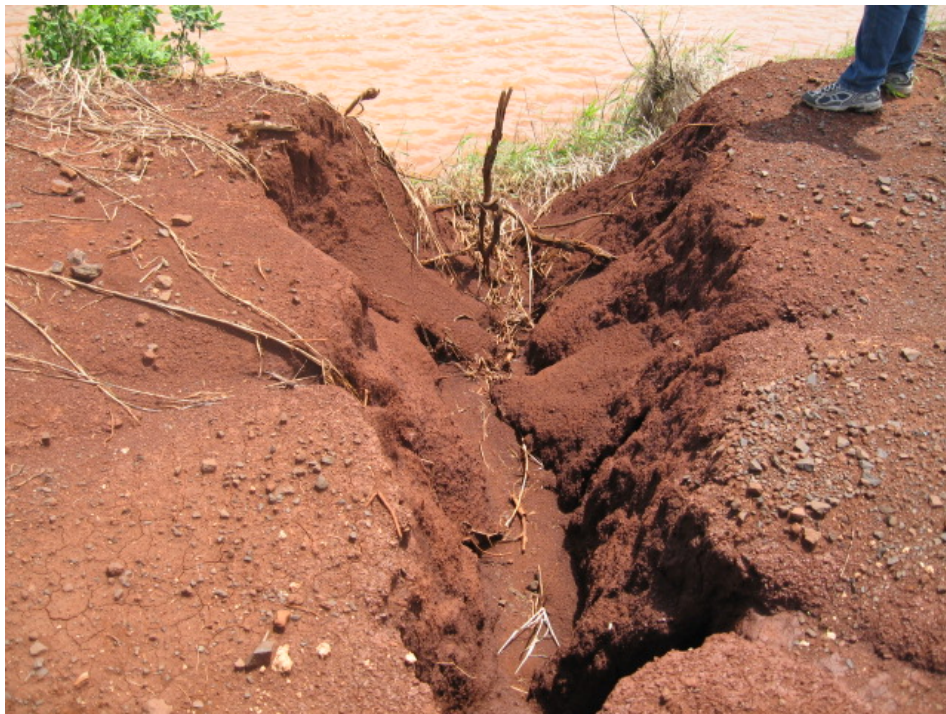
A major erosion gully was observed, which extends to the upstream slope. The gully is 7 ft long, 5 ft wide, and 4' deep.

Photo 2 Erosion gully on crest and upstream face.

- ☐ e. Access along the crest was satisfactory.
- ☐ f. Access along the crest was not possible. Description: _____
- ☒ g. Rut and/or Gully erosion was observed on the crest, which requires maintenance and/or repair.
Description: Gully ~~to~~ erosion severe should be repaired may effect integrity of dam

- a. The dam crest appeared to be in unsatisfactory condition and not expected to fulfill its intended function. Urgent corrective action is required.
- b. Access along the crest was satisfactory.
- c. Rut and/or Gully erosion was observed on the crest, which requires maintenance and/or repair. Description: Gully erosion severe and needs to be repaired. This may effect the integrity of the dam at a higher pool. This gully should be excavated first to develop a good surface to place and compact fill. The fill needs to be graded to drain away from the US slope.

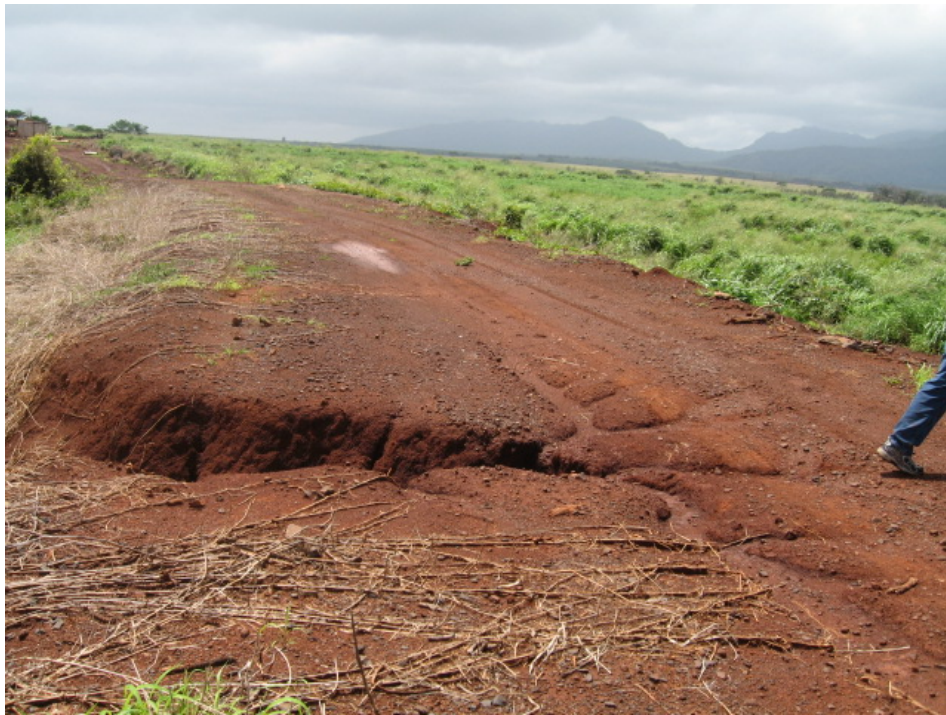
Photo 3 Same as above looking along the crest.

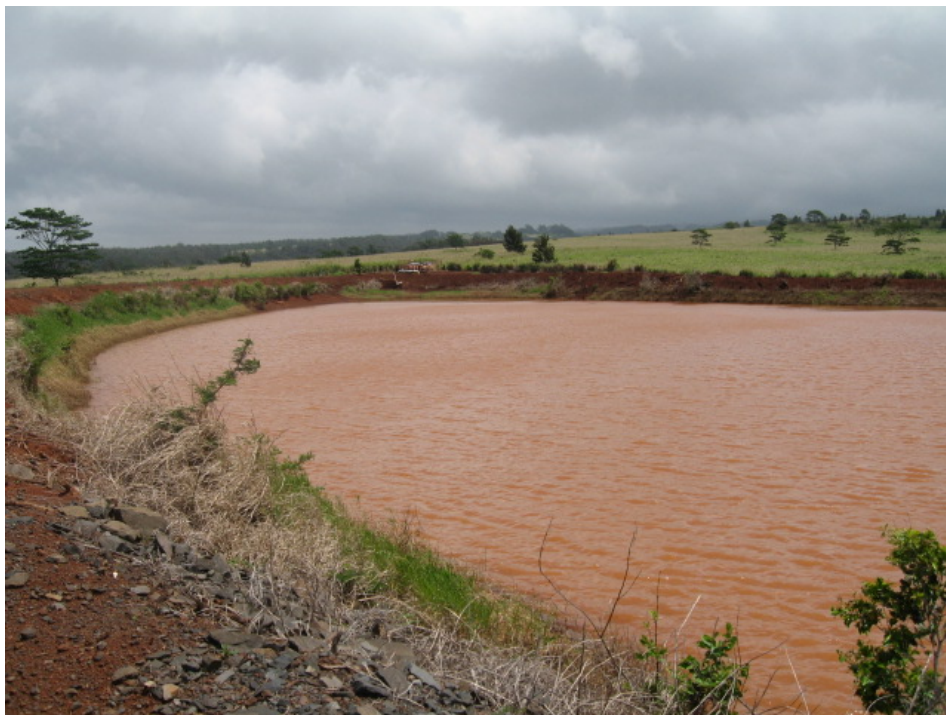
The upstream slope was roughly 1V to 2H (Vertical / Horizontal)
There was no slope protection observed.
Small erosions ruts were observed.
Cracks were not observed.
Sinkholes were not observed.
There were a few small trees and bushes on the slope.

Photo 4 Upstream slope.

- a. The upstream slope appeared to be in fair to poor condition and requires corrective action.
- b. Rut and/or Gully erosion was observed on the slope, which requires maintenance and/or repair. Description: Regrade and repair ruts. Establish low vegetation to prevent erosion.
- c. Tree(s) were observed on the dam embankment. Trees have been identified as the probably cause of piping failures, and can possibly cause sever damage to the embankment if they are uprooted during a high winds. Corrective action is required to remove the tree hazards from the dam. Acceptable remedies include removal of the tree and its root structure down to a 2" diameter and reconstructing the damaged embankment section. All repair work shall be

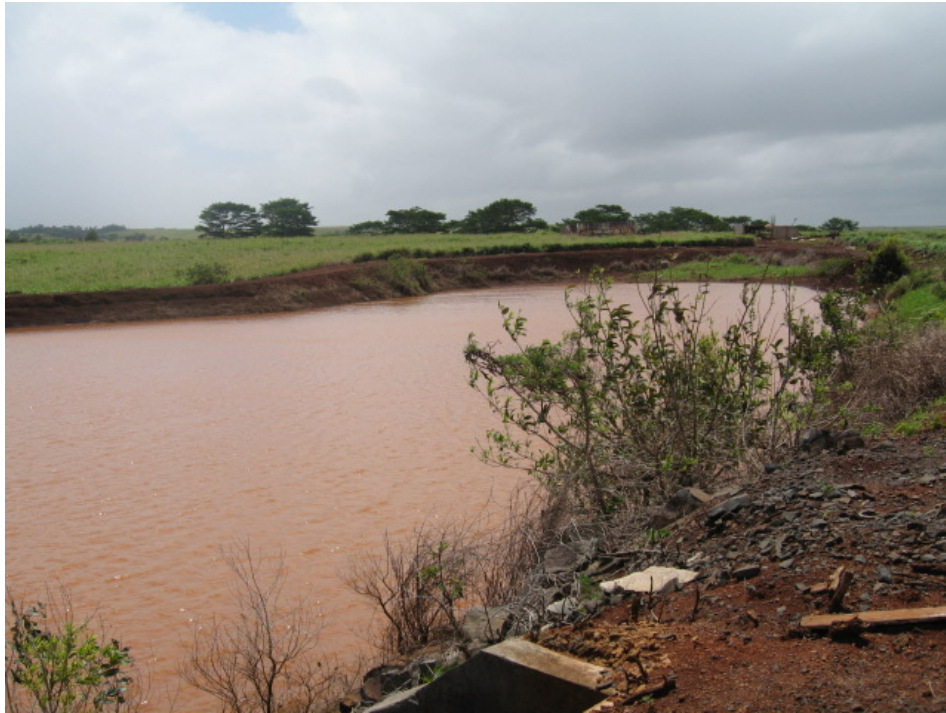
Photo 5 Upstream slope looking towards entrance.

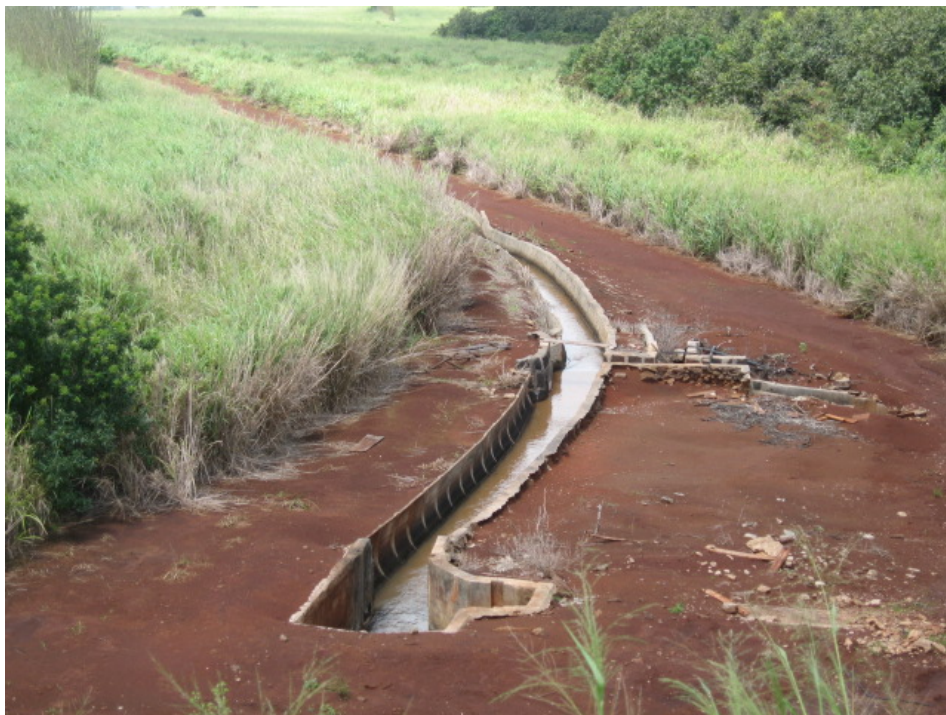
Photo 6 Outlet and spillway channel.

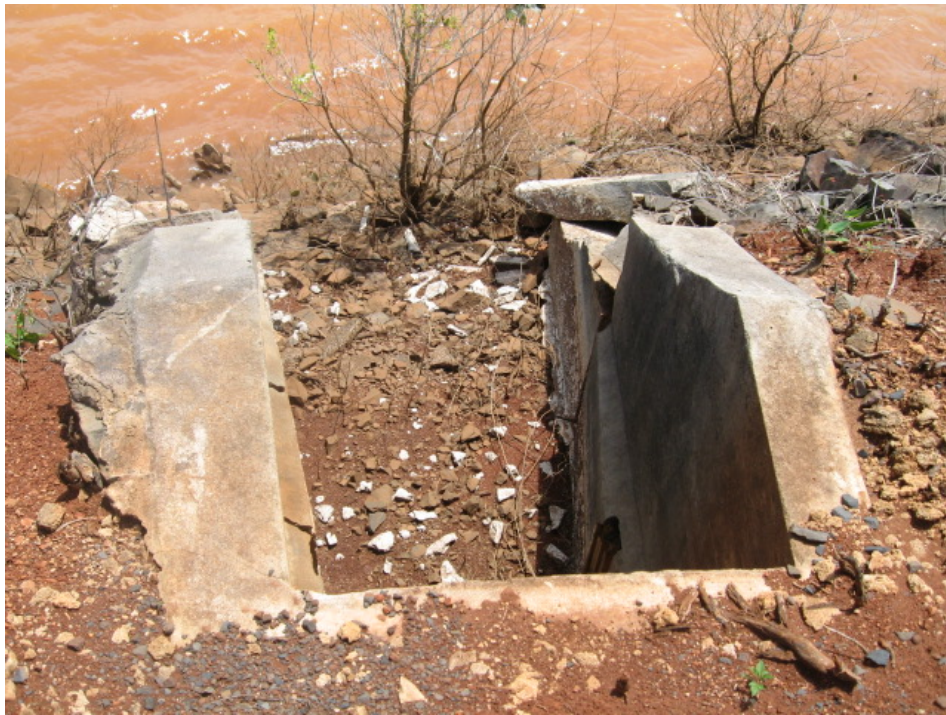
Photo 7 Spillway entrance.

- a. The Spillway appeared to be in satisfactory condition, no corrective actions are required at this time.
- b. Unclear if spillway is adequately sized. Spillway should pass the probable maximum flood. Verify spillway capacity and take corrective action as required.

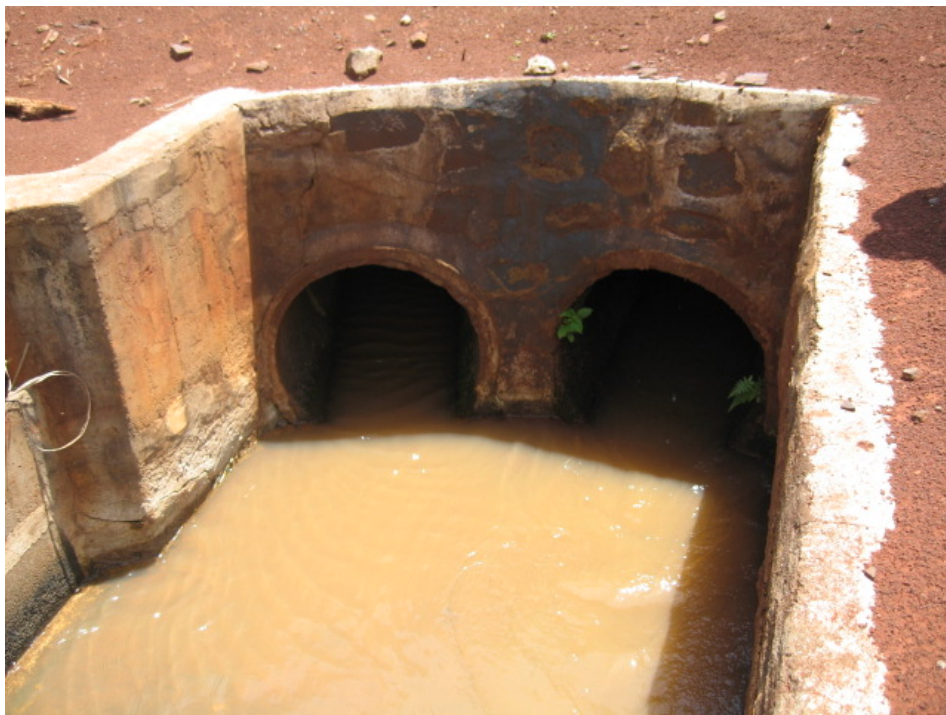
Photo 8 Outlet pipes.

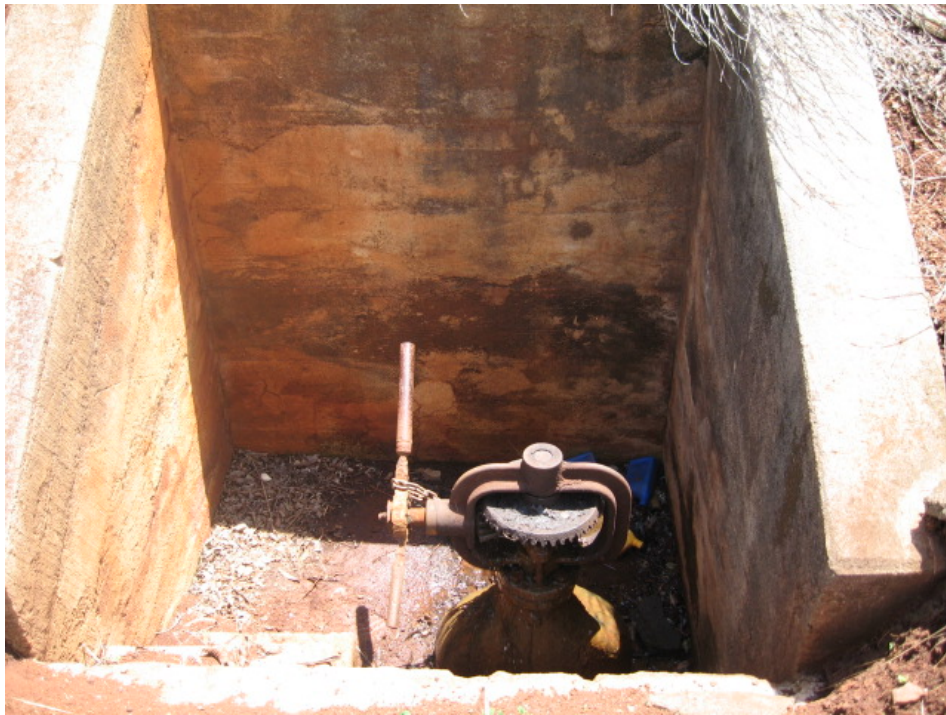
Photo 9 Outlet valve.

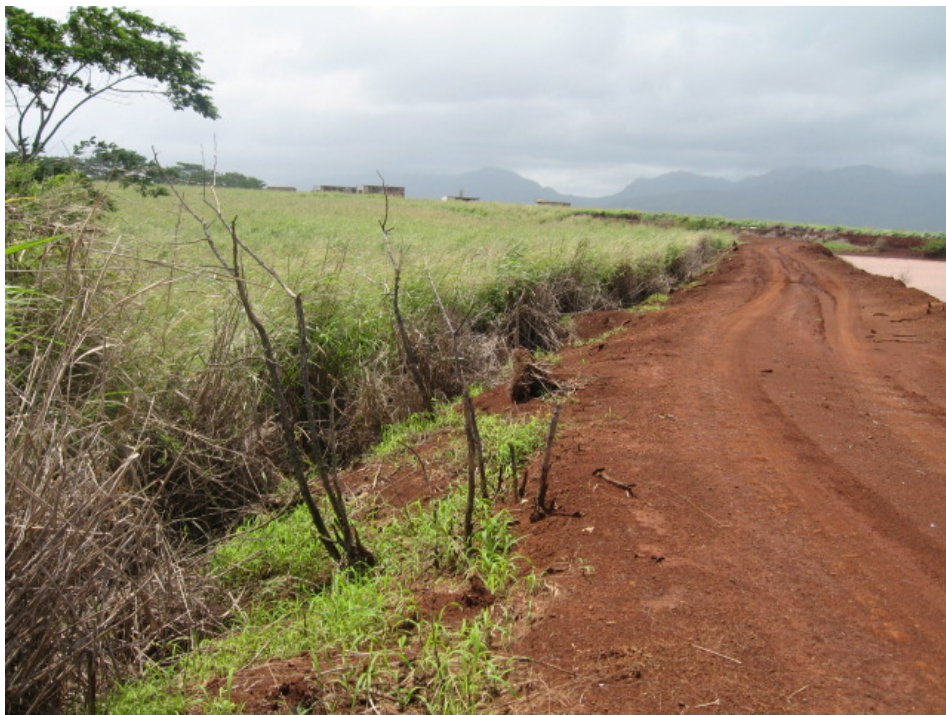
Vegetation was observed on the downstream slope. The majority of the vegetation was tall grass.

Photo 10 Downstream slope, dense vegetation.

- a. The downstream slope was not inspected.
- b. The downstream slope appeared to be in fair to poor condition and requires corrective action.
- c. The down stream slope was not visible due to high grass and bush vegetation. Clear high vegetation and maintain low to enable easy visual inspection.

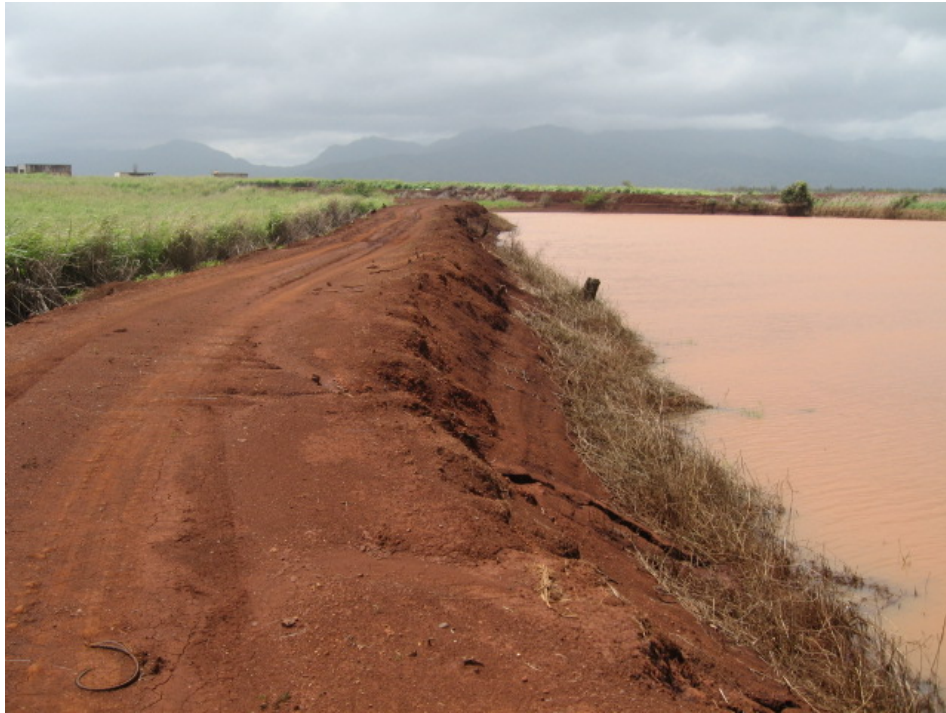
Photo 11 Upstream slope erosion.
